Household LPG cylinder fracture and a boiling liquid expanding vapor explosion

D.T. Chondrou¹, I.T. Chondrou², S.D. Panteliou³, T.G. Chondros³

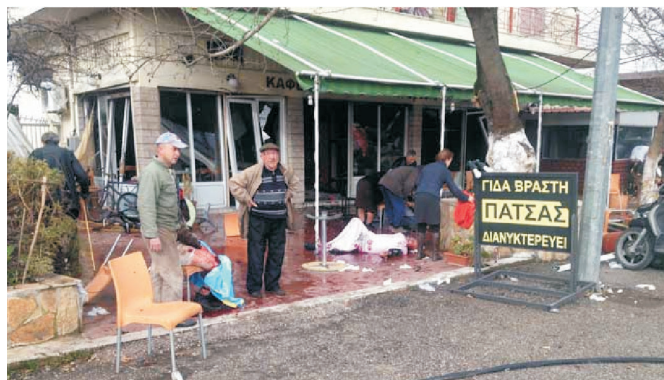
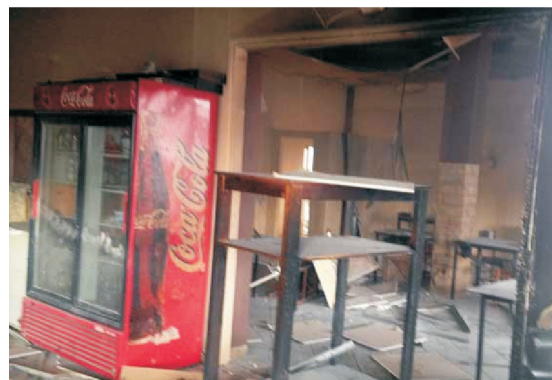
Figure 1. Damages to the restaurant's openings from the blast wave after the LPG pressure cylinder explosion and injured persons outside the restaurant (*a*), and the interior disintegrated (*b*)

It was a safe coincidence that the missile did not damage other vessels in the same area storing liquefied gas under pressure. This could cause them to undergo BLEVE as well. Further, the mixture of liquid/gas released by the explosion catches fire, giving rise to a fireball in the interior of the building as noticed by witnesses also (see Figure 1).

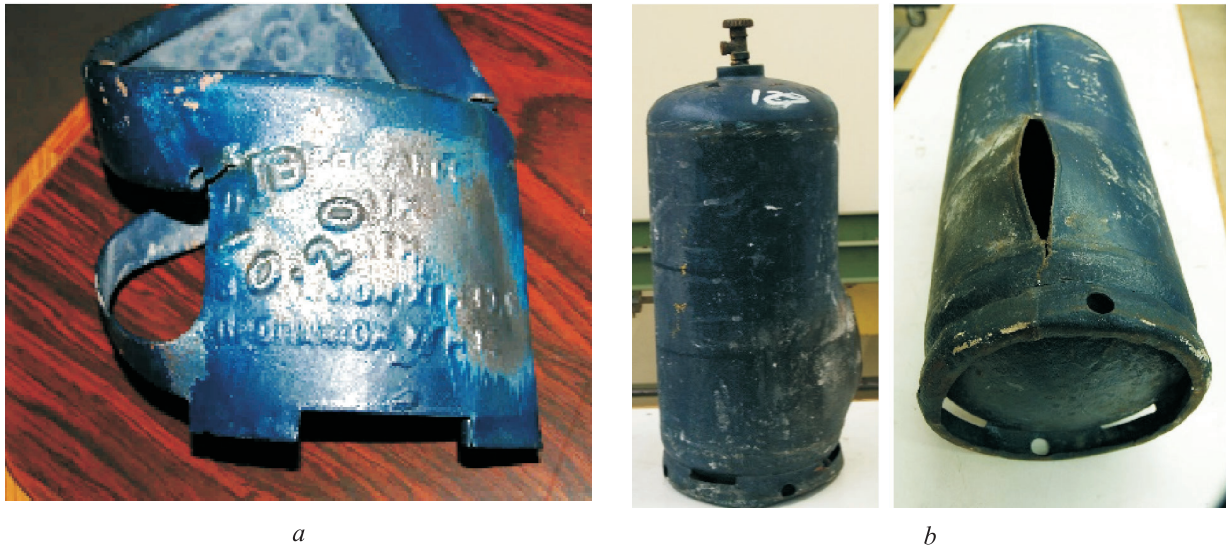
Figure 2 shows the LPG cylinder after the BLEVE explosion with the fractured side weld. The LPG cylinder On top of the cylinder the flow vane was intact and tightly closed. The cylinder diameter and length were measured 250 mm and 400 mm respectively. The cylinder's bottoms height was measured 60 mm.

On the cylinder top protection structure (Figure 2, *a*) it is indicated the year of construction, 1965, the manufacturer of the cylinder, shell thickness 2.8 mm, tank volume 25 l, max volume capacity 23.8 l, empty weight 12.6 kg, and capacity: butane 10.9 kg, and propane 13.0 kg. On the top protection frame there is the indication 20 with large bold numbers, presumably the test pressure of the LPG cylinder. The damage to the side weld is shown in Figure 2. The fractured cylinder weld of length 170 by 30 mm wide opening is also depicted in Figure 2, *b*.

Figure 2. The LPG cylinder after the BLEVE explosion, the upper protection, year of construction 1965, pressure test 2 MPa (a), cylinder length 400 mm, diameter 250 mm, spherical bottoms height 60 mm, radius of curvature $R = 280$ mm, and the weld failure (b)

The cracking pattern of the cylinder (see Figure 2) indicates internal gaseous detonation associated with supersonic speed of the combustion wave front. Triggering of this detonation in LPG containers is due to a sudden depressurization of the container leading to instantaneous and violent vaporization of the content, causing the BLEVE.

The weld thickness is less than 3 mm, thus no preparation of the edges was required as it is the case in the cylinder investigated. Plastic deformation of the ruptured part of the lateral weld (see Figure 2) indicates a bursting failure. In engineering practice, the allowable stresses, safety and stress concentration factors are based on the convention that failure is due to shear at the narrowest section (throat) of the weld. Due to catastrophic failures of early welds in pressure vessels and steel constructions, the design of welds is highly regulated [1].

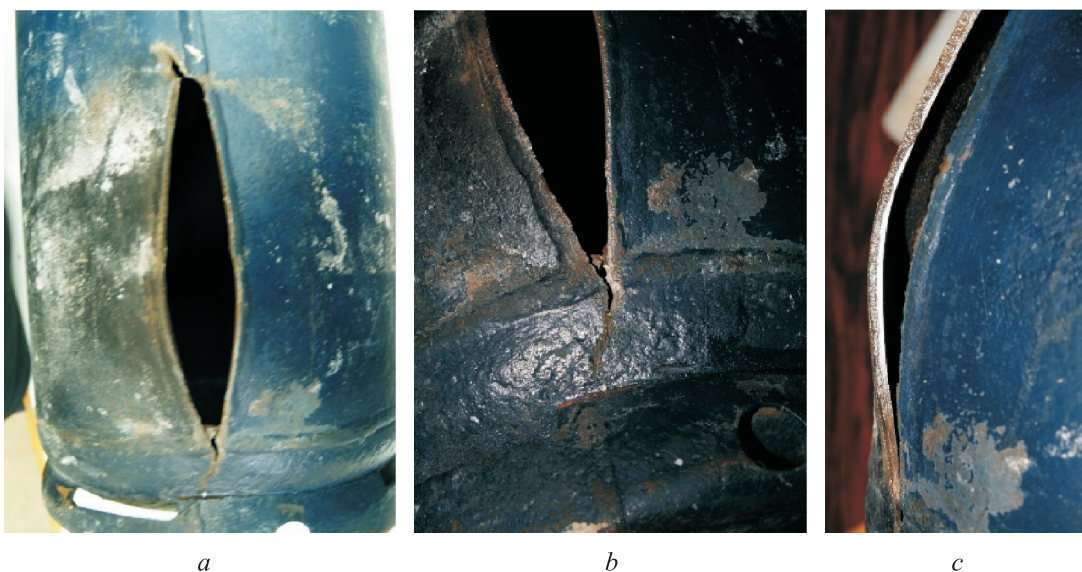
Figure 3 shows details of the part of the cylinder connected to the lower dome (a) and the 170 mm long side welding fracture (c). Examination of the fractured weld of the cylindrical part of the shell shows that weld penetration reaches 1.10–1.50 mm depth out of the 2.80 mm shell thickness at a length

of 30 mm of the fracture. Furthermore, careful examination of the area around the fracture both in the cylinder and the dome (see Figure 2 and 3) reveal corrosion defects and corrosion pits.

Examination of the lower dome beneath the crack opening on the cylinder revealed an area with significant corrosion pits and minor crack initiation (see Figure 3, b). Also, local damages due to impact was observed at the fractured area of the lower dome stimulating the crack initiation. The site of identified provides information that pre-cracking caused by fatigue, corrosion pits, stress corrosion, and material defects led to crack propa-

Figure 3. The LPG cylinder after the BLEVE explosion, the 170 mm fractured cylinder lateral weld, the lower dome peripheral weld (a), corrosion defects and corrosion pits at the lower dome (b) and lateral cylinder weld penetration 1.10–1.50 mm out of the 2.80 mm shell thickness at a length of 40 mm (c)

gation, and furthermore to rupture. This fatigue crack was slowly developed until a substantial leak of the cylinder content was released to the atmosphere, leading to a BLEVE.

Cylinder side weld. The rupture took place in the area of welding the cylindrical part of the shell of the pressure cylinder with the lower spherical dome (see Figure 3). This is an area of increased local stresses. In addition, the rupture crosses two adjacent welds, of a Tee shape junction, yielding a complicated stress field. From the examination of the ruptured cylinder lateral butt weld it was investigated inadequate weld depth (see Figure 4).

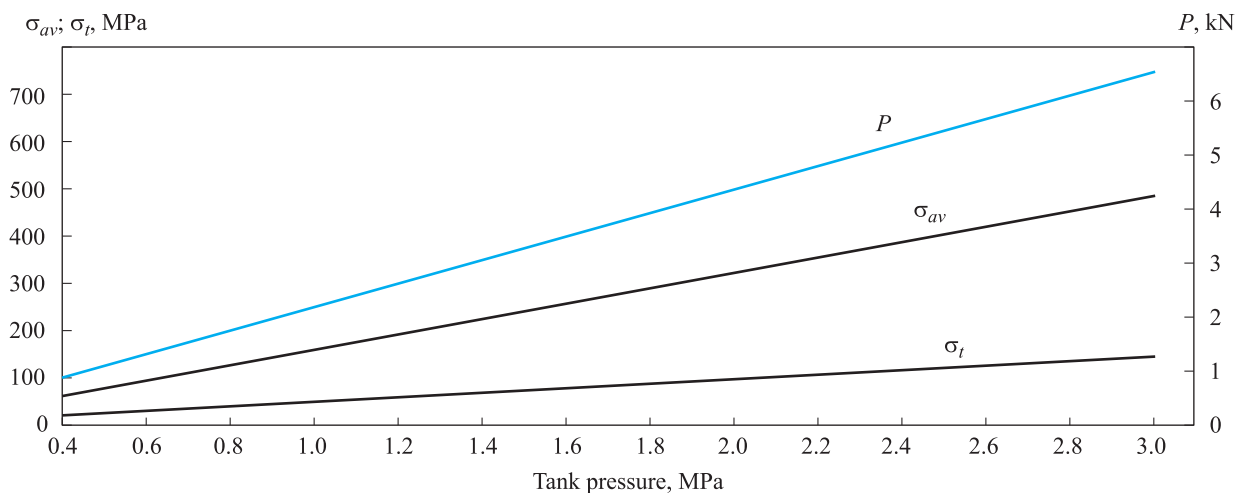
In Figure 5 the tensile stress (upper curve) at the section with reduced weld penetration (cold weld), ranges from 75 MPa corresponding to an operating pressure of 0.04 MPa, up to 320 MPa corresponding to an operating pressure of 2 MPa. From Figure 5 it appears that the stress calculated above for the weakened area of the welding, $\sigma_t = 175$ MPa for normal operation of the LPG cylinder (up to 1 MPa internal pressure) is lower than the material fatigue strength limit $S'_n = 192$ N/mm² [1], and the design is quite safe even for low cycle fatigue operation.

Furthermore, cylinder operation at 40–50 °C ambient temperature, yields 1.7–2.0 MPa internal pressure, and the stress in the reduced penetration section weld lies in the area 275–320 MPa as shown in Figure 5, all values being lower than the

Figure 5. Tensile force at the reduced penetration (cold weld area) P , tensile stress σ_{av} at cold weld and circumferential stress σ_t at the lateral cylinder weld

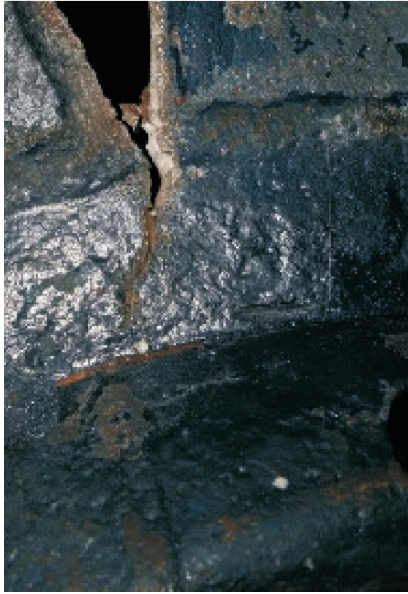
Figure 6 shows the crack initiation and branching of the crack on the bottom dome. The lower edge of the crack starts from the peripheral weld connecting the bottom dome with the lower support ring frame (see Figure 3, a). Then the crack propagates heading the peripheral weld with the cylinder (Tee-weld). There are two branches of this crack, one heading to the left at an angle of 115° (from a horizontal axis), and a branch heading 75° to the right towards the cylinder side weld.

The left branch of the same crack initiation is still covered by paint indicating a less fast propagation than the right branch. The right

Figure 6. The crack initiation and branching of the crack on the bottom close to the peripheral weld (connecting the bottom dome with the lower support ring frame)

branch of the crack propagating towards the peripheral weld with the cylinder and fractured causing the liquid to escape and a pressure drop.

Low cycle fatigue loading in the presence of the stress intensity factors calculated before caused the flaw to gradually increase, and form a propagating crack until the remaining section of the material could no longer sustain the load. Then the crack propagates rapidly, causing final failure. This crack propagation and rupture shown in Figure 6 led to the subsequent gas discharge in the atmosphere and the BLEVE explosion.

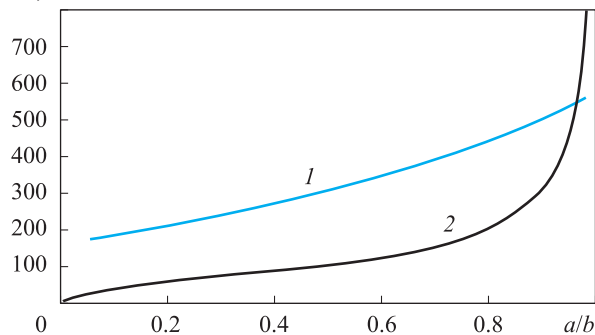
The stress intensity factors curves shown in Figure 8 provide the stress threshold for brittle crack initiation at the bottom dome. It can be seen from Figure 8 that in case of a surface crack in a strip of width 50 mm, for $a/b = 0.79$, yielding a crack length $2a = 39 \text{ mm}$, the stress intensity factor becomes $K = 196 \text{ MPa}$ larger than the material fatigue tensile strength limit $S'_n = 192 \text{ MPa}$ (192 N/mm^2). This stress state leads to a fatigue crack propagation.

On the other hand, for an edge crack, and $a/b = 0.50$, yielding a crack length $a = b = t/2 = 1.4 \text{ mm}$, and $a/b = 1.50$, yielding a crack length $a = 1.5 b = 1.5t/2 = 2.1 \text{ mm}$. In other words, for an edge crack of depth 1.4 mm, 50% the dome thickness, the stress intensity factor becomes $K = 329 \text{ MPa}$. For crack depth 2.1 mm, 77 % of the dome thickness, the stress intensity factor becomes $K = 438 \text{ MPa}$, both limits being larger than the material Yield Limit $S_y = 300\text{--}420 \text{ MPa}$, and rupture will occur.

Figure 8. Stress intensity factors for an edge crack (1) and a surface crack (2)

length of a surface crack $2a = 39 \text{ mm}$ similar to the crack shown in Figure 6, crack propagation could be the case for low cycle fatigue loading. Then the analysis provides an estimation of the depth of an edge crack on the bottom dome surface that produces a stress field with tensile stresses larger than the material Yield Limit yielding rupture.
