Household LPG cylinder fracture and a boiling liquid expanding vapor explosion

D.T. Chondrou¹, I.T. Chondrou², S.D. Panteliou³, T.G. Chondros³

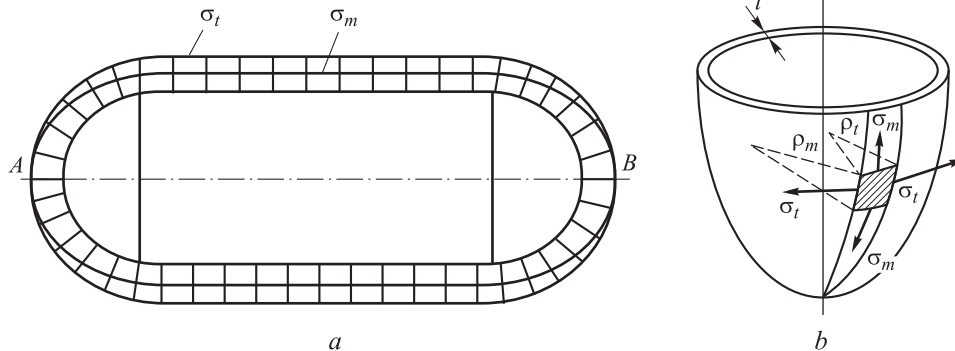
Figure 4. A thin walled pressure vessel, profiles of the circumferential stress σ_t , the meridional or axial stress σ_m (a) and equilibrium of a membrane element (b)

Cylinder side weld. The rupture took place in the area of welding the cylindrical part of the shell of the pressure cylinder with the lower spherical dome (see Figure 3). This is an area of increased local stresses. In addition, the rupture crosses two adjacent welds, of a Tee shape junction, yielding a complicated stress field. From the examination of the ruptured cylinder lateral butt weld it was investigated inadequate weld depth (see Figure 4).

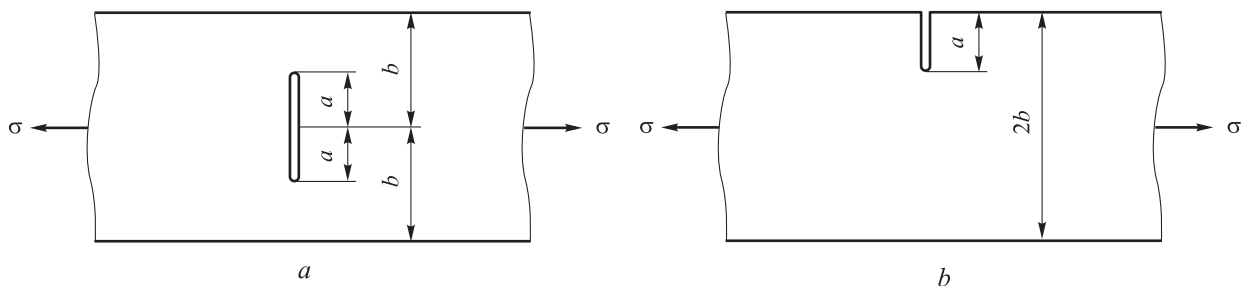
For an infinite strip, that is, if the strip boundary is very far from the crack $F(a) = 1$. For the case under consideration two cases will be examined along with the appropriate assumptions for the stress field: 1) considering the crack initiation in Figure 6 as a surface crack located at mid-span of an infinite strip of width $2b$ (Figure 7, *a*), under the action of a tensile stress σ acting on the strip, and 2) considering the crack as an edge crack of depth a , and $2b = 2.8$ mm the bottom dome thickness (Figure 7, *b*) gain under the action of a tensile stress σ acting on the strip.

Then equation (10) yields the corresponding stress intensity factors for each case. The function $F(a)$ associated with stress and the crack length for the crack configurations shown in Figure 7, *a* and Figure 7, *b* is respectively [1]. For the cracked strip shown in Figure 7, *a*, strip width $2b$ and a surface crack opening $2a$, the stress intensity factor is calculated from equation (10), assuming $F(a) = f(a/b)$, $a/b = \lambda$, and the values of $f(a/b)$ can be found in [1] (APPENDIX B) as

For the cracked strip shown in Fig 7, *b*, strip of thickness $2b$ and an edge crack of depth a , the stress intensity factor is calculated from equation

Figure 7. A strip of metal subjected to a tensile stresses σ :

a — strip width $2b$, surface crack of length $= 2a$; *b* — strip thickness $2b$, with an edge crack of depth *a*
